**DEPARTMENT OF TRANSPORTATION**

Contract #: 04-0120F4Cty: SF/ALA Rte: 80 PM: 13.2/13.9File #: 69.28**WELDING INSPECTION REPORT****Resident Engineer:**Siegenthaler, Peter**Address:** 333 Burma Road**City:** Oakland, CA 94607**Report No:** WIR-020655**Date Inspected:** 15-Feb-2011**Project Name:** SAS Superstructure**OSM Arrival Time:** 700**Prime Contractor:** American Bridge/Fluor Enterprises, a JV**OSM Departure Time:** 1900**Contractor:** Zhenhua Port Machinery Company, Ltd (ZPMC), Changxing Island **Location:** Shanghai, China**CWI Name:** Mr. Sha zhi**CWI Present:** Yes No**Inspected CWI report:** Yes No N/A**Rod Oven in Use:** Yes No N/A**Electrode to specification:** Yes No N/A**Weld Procedures Followed:** Yes No N/A**Qualified Welders:** Yes No N/A**Verified Joint Fit-up:** Yes No N/A**Approved Drawings:** Yes No N/A**Approved WPS:** Yes No N/A**Delayed / Cancelled:** Yes No N/A**Bridge No:** 34-0006**Component:** Orthotropic Box Girder( OBG)**Summary of Items Observed:**

## WELDING INSPECTION REPORT

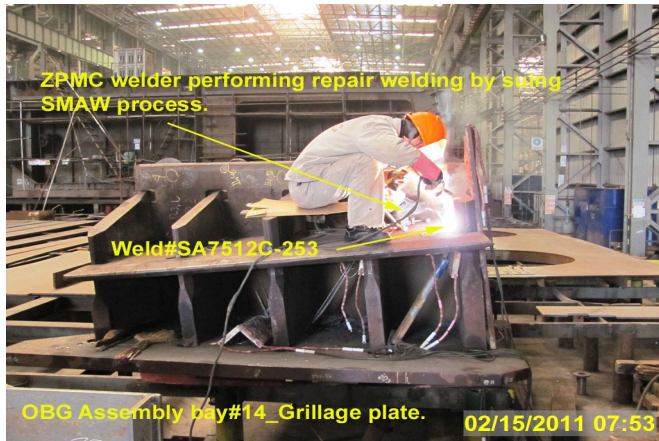
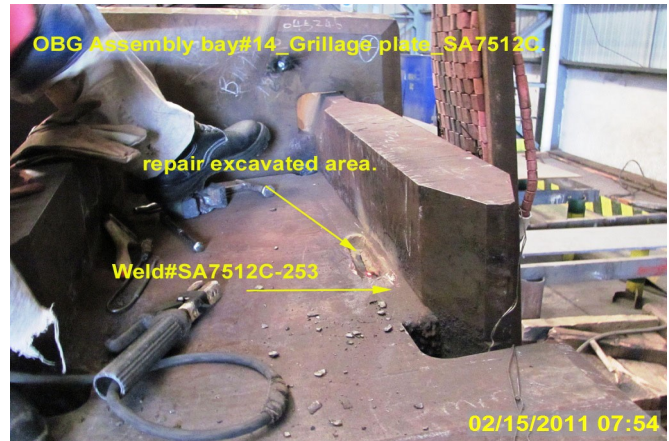
SMAW Repair welding of weld joint identified as SA7512C-253. Welder is identified as 047864. ZPMC Quality Control (QC) is identified as Mr. Zheng zhi wei. The welding variables recorded by QC personnel observed appeared to comply with WPS: WPS-345-SMAW-1G (1F)-FCM-Repair. The repair welding was being performed as per Critical Welding Repair Report (CWR) No: B-CWR2629 Rev.No.3. This weld was previously rejected by ZPMC QC personnel and recorded on UT report B787-UT-18524R3. Refer the attached photos for reference.

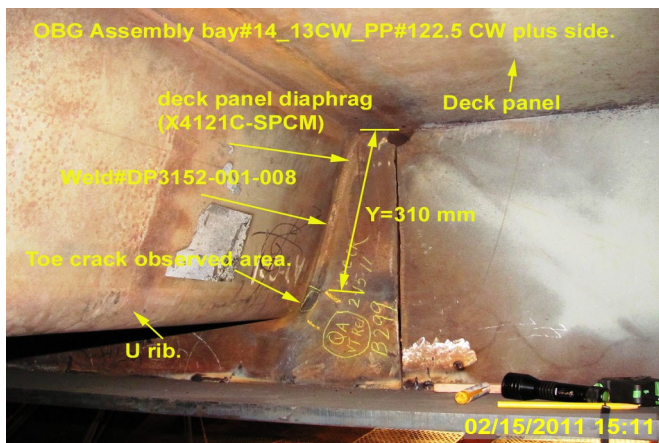
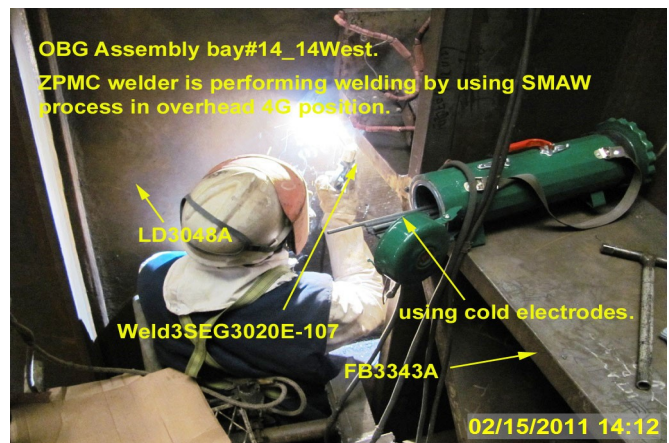
During random Visual Testing of OBG lift 13CW at Panel Point (PP) #122.5 Counter weight side Deck Panel identified as DP3152A, this QA observed one longitudinal linear toe crack measuring approximately 30 mm in length. The weld joint is identified as DP3152-001-008. The weld is fillet joining to deck panel diaphragm (X4121C) to U rib. The “Y” location is approximately 310 mm from top as shown on the picture below. This QA marked the area and informed ZPMC Quality Control (QC) Inspector identified as Mr. Zhang lin of this issue. Mr. Zhang lin informed this QA that the weld joint would be corrected in a manner compliant with the contract documents. This QA also informed the above issue to shop Lead QA inspector (verbally). Refer the attached photos for reference.

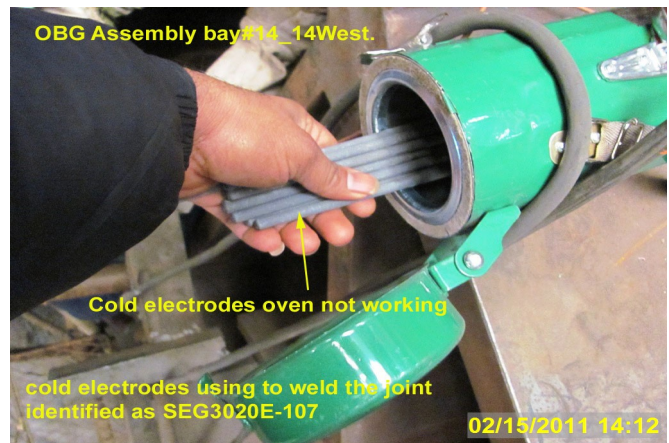
During random in process inspection of OBG lift 14West hinge plate FB3343A and Longitudinal diaphragm LD3048A, this QA observed welder was using cold electrodes during welding by using SMAW process. The weld joint is identified as SEG3020E-107. The weld is complete joint penetration joining to floor beam (FB3343A) to longitudinal diaphragm LD3048A. This QA informed ZPMC QC Inspector identified as Mr. Zhulin of this issue. Mr. Zhulin instruct the welder to discard the cold electrodes and new electrodes shall be used which are compliant with the contract documents. This QA noted that welder immediately removed all the electrodes from the oven and discard the cold electrodes. This QA also informed the above issue to shop Lead QA inspector (verbally). Refer the attached photos for reference.
